HA-1172
FULLER-MEZEI APARTMENTS
Havre de Grace, Md.

INVENTORY FORM FOR STATE HISTORIC SITES SURVEY

Fuller - Mezei Apts.

327 S. Union Ave.

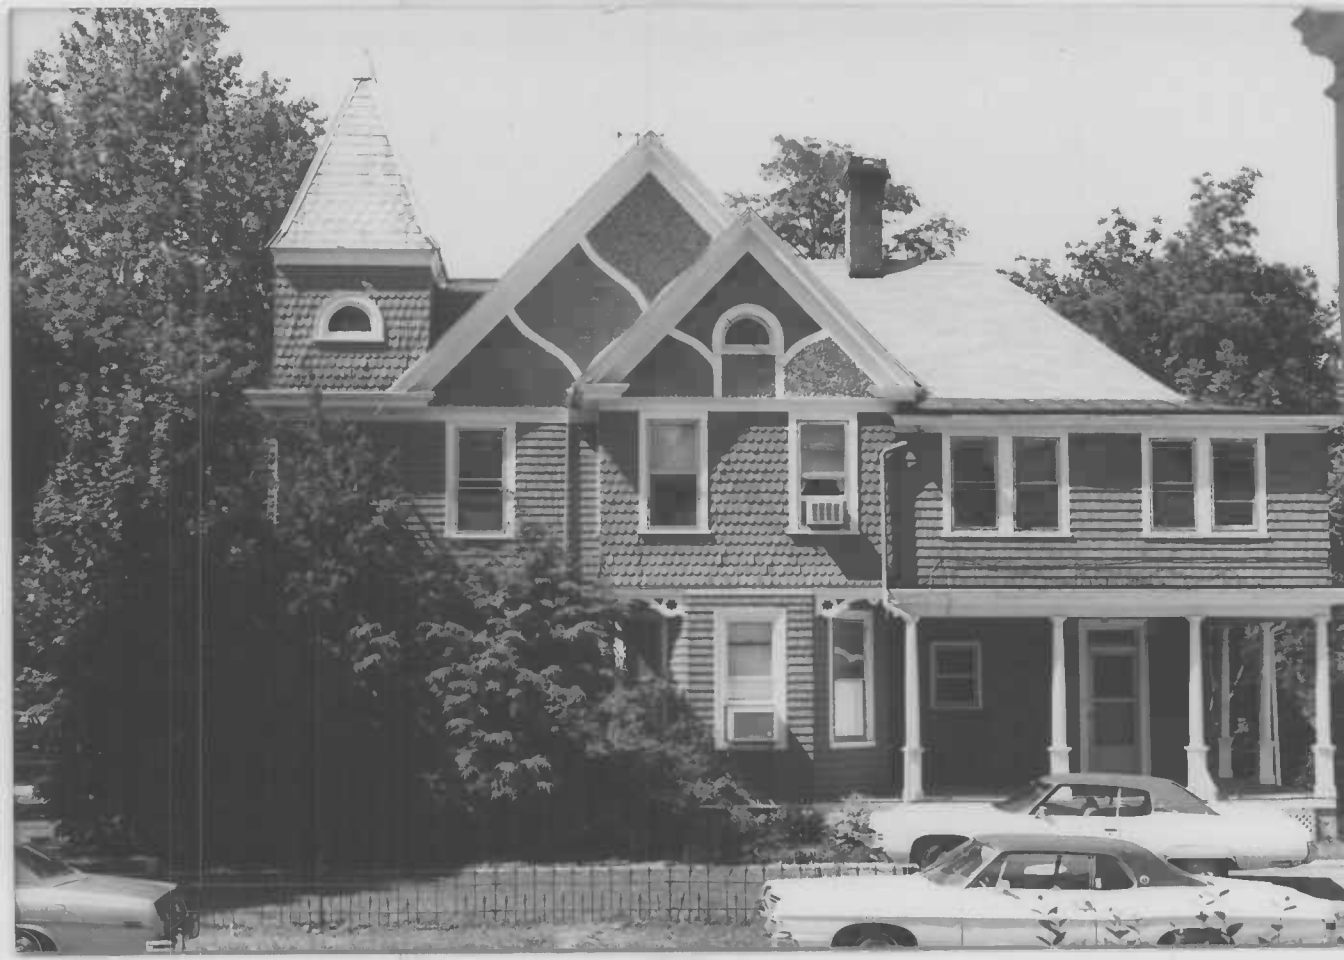
HA-1172

The gables and tower have round arched windows. A two story gabled bay addition extends from the center of the south elevation. It is three sided on the first story and the second story, covered with imbricated shingles, is rectangular while the attic gable is finished with stucco, pebbles, and curved timbers. Scroll brackets emphasize the division between the 1st and second story on the bay addition.

Fuller-Megeeⁱ Apts
327 S. Union Ave
Havre de Grace, Md.
South Elev.

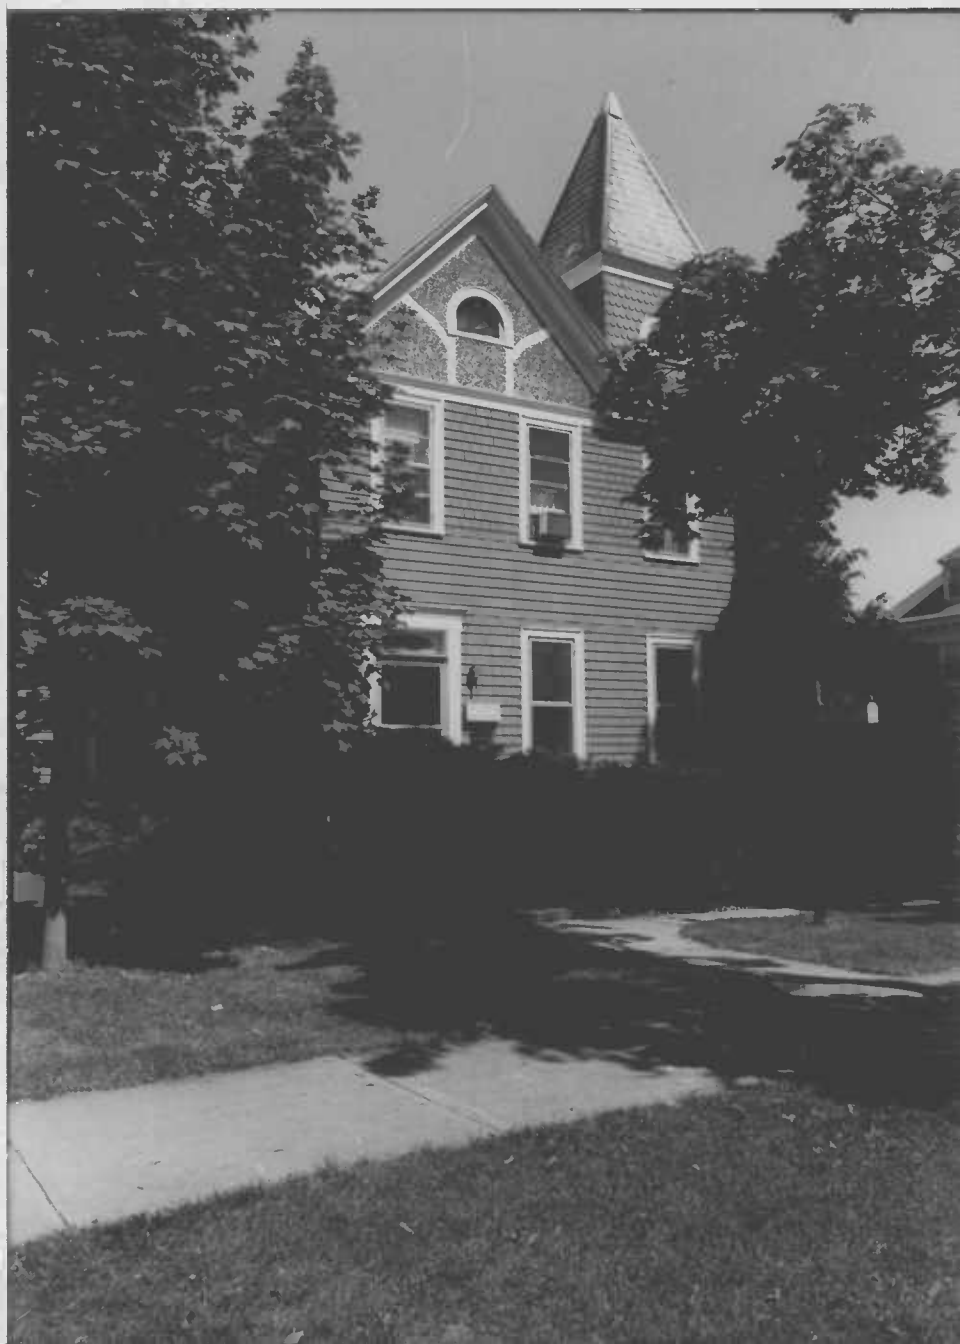
HA-1172

Windows are arranged symmetrically on the facade. There, as on the rest of the house, they contain 1/1 light sash, framed with wide boards. A one story pentagonal bay projects from the north elevation. It has a small rectangular window in the top half of the center bay which contains stained glass.

Fuller-Mezeyⁱ~~z~~ Apts
327 S. Union Ave.
Havre de Grace, Md.

West Facade
